Technical Report CHL-97-13  
July 1997

*Monitoring Completed Navigation Projects Program*

## **Monitoring of Harbor Improvements at St. Paul Harbor, St. Paul Island, Alaska**

by *Robert R. Bottin, Jr., WES*  
*Kenneth J. Eisses, Alaska District*

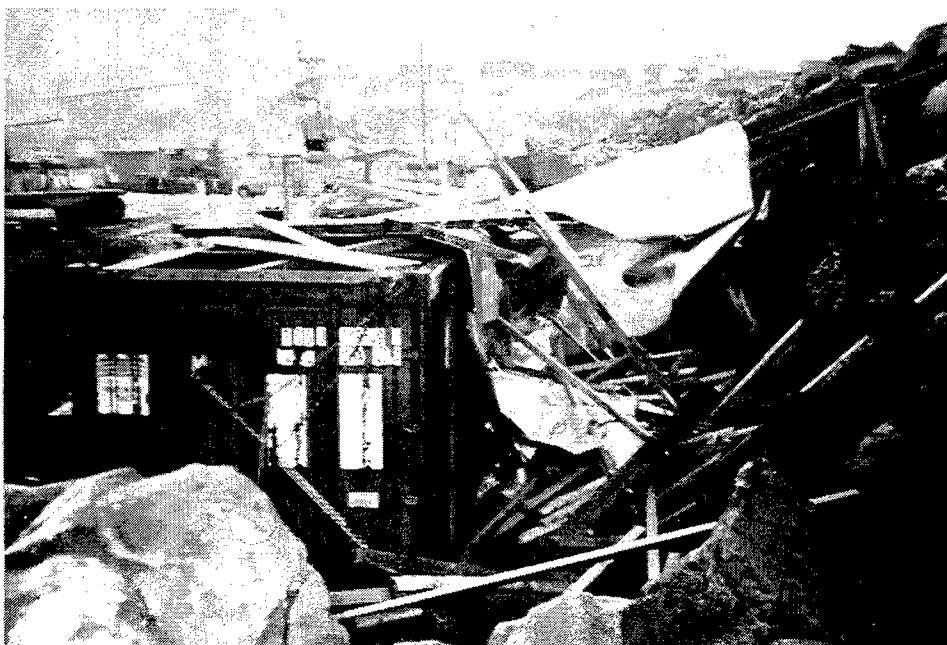
Figure 22. Collapsed apron resulting from 3 November 1994 storm

for 2.6-m (8.5-ft) waves indicate a runup value between 4.9 and 5.2 m (16 and 17 ft) would occur (based on *Shore Protection Manual* predictions); however, massive overtopping actually occurred that resulted in destruction of the apron. Local forecasts indicated winds of 50 knots and seas of 9.1 m (30 ft) on 3 November 1994. Based on these comparisons, the hindcast data appear to have under-estimated wave conditions at the site. As stated earlier, in general, trends indicated larger waves occurred with higher runup values and wave overtopping, but absolute values of the wave heights generated by the hindcast model appeared low.

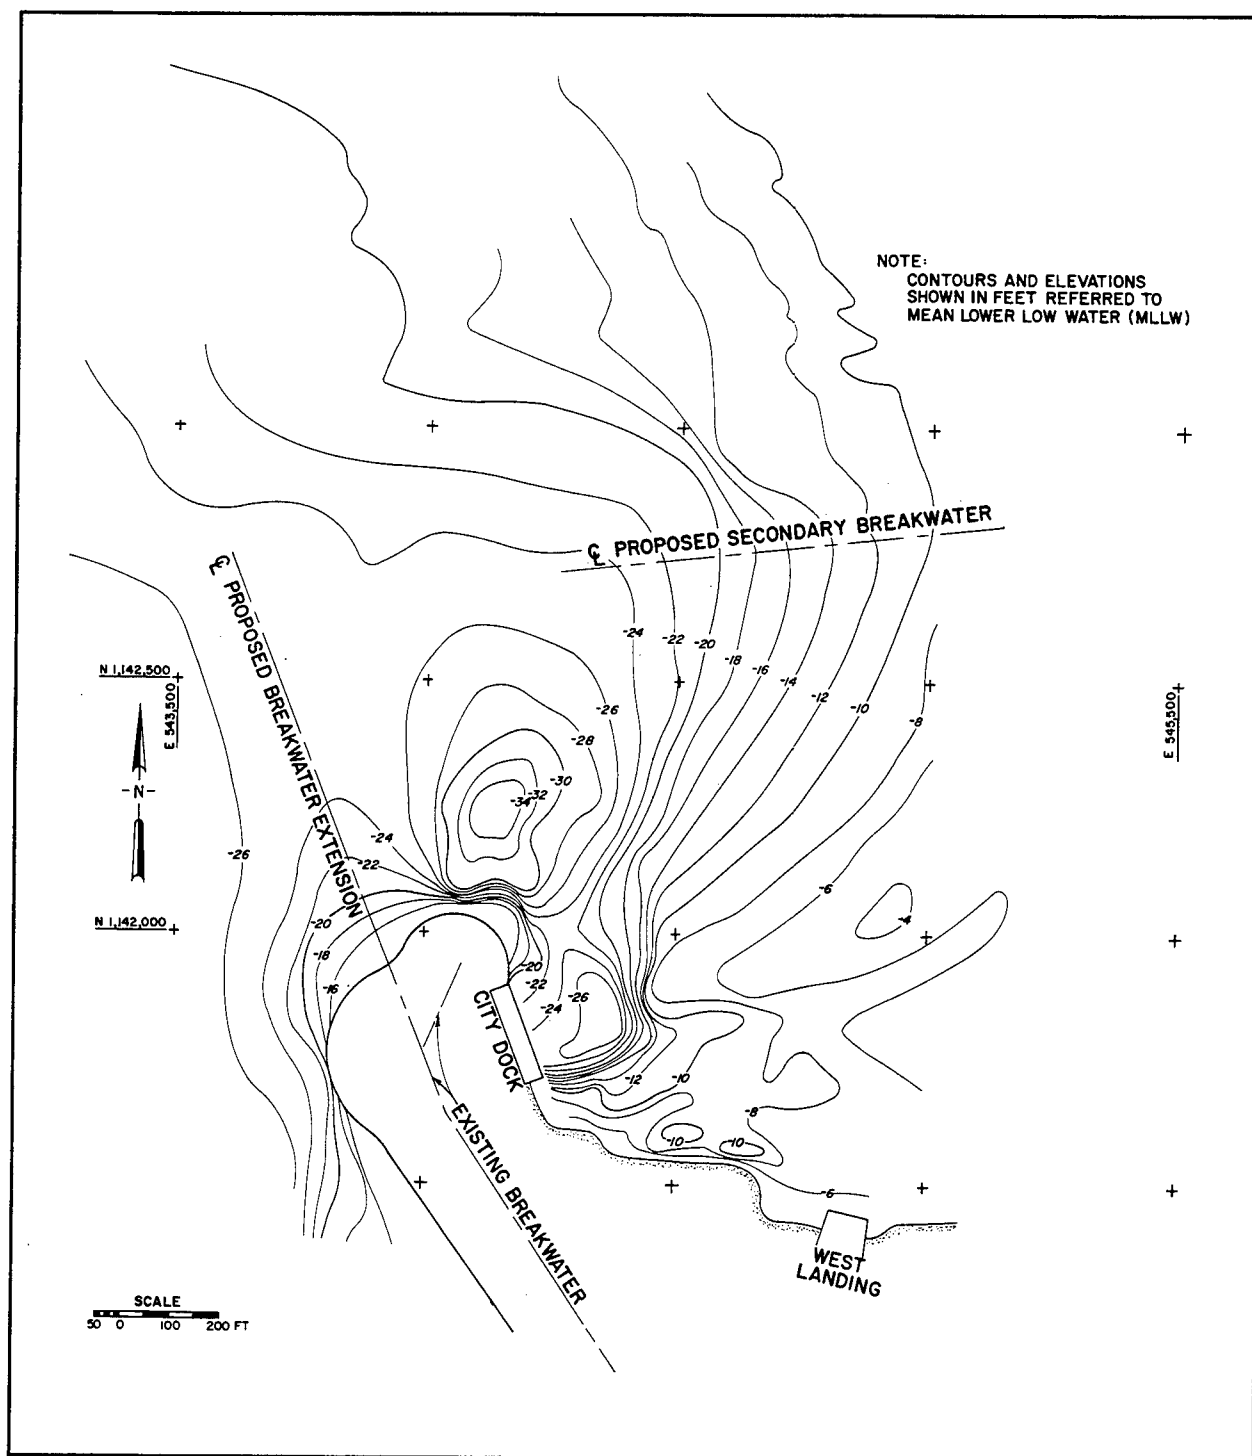
Bathymetric data obtained in and adjacent to the harbor in September 1986 (prior to construction of breakwater improvements) are shown in Figure 24. Note the 10.4-m (34-ft) el scour hole adjacent to the head of the breakwater. The scour hole formed after construction of the original 229-m-long (750-ft-long) breakwater in 1985. It was monitored by CENPA and did not tend to undermine the breakwater foundation. Depths adjacent to the vertical-walled, concrete caisson City Dock were dredged to greater than 6.1 m (20 ft). Though not shown in the bathymetry, CENPA noted that the cove appeared to begin filling in after initial breakwater construction with accretion along the southeast shoreline of Village Cove. At one point the connecting channel between the cove and saltwater lagoon was plugged and subsequently artificially reopened.

Figure 24. Bathymetry at St. Paul Harbor, September 1986

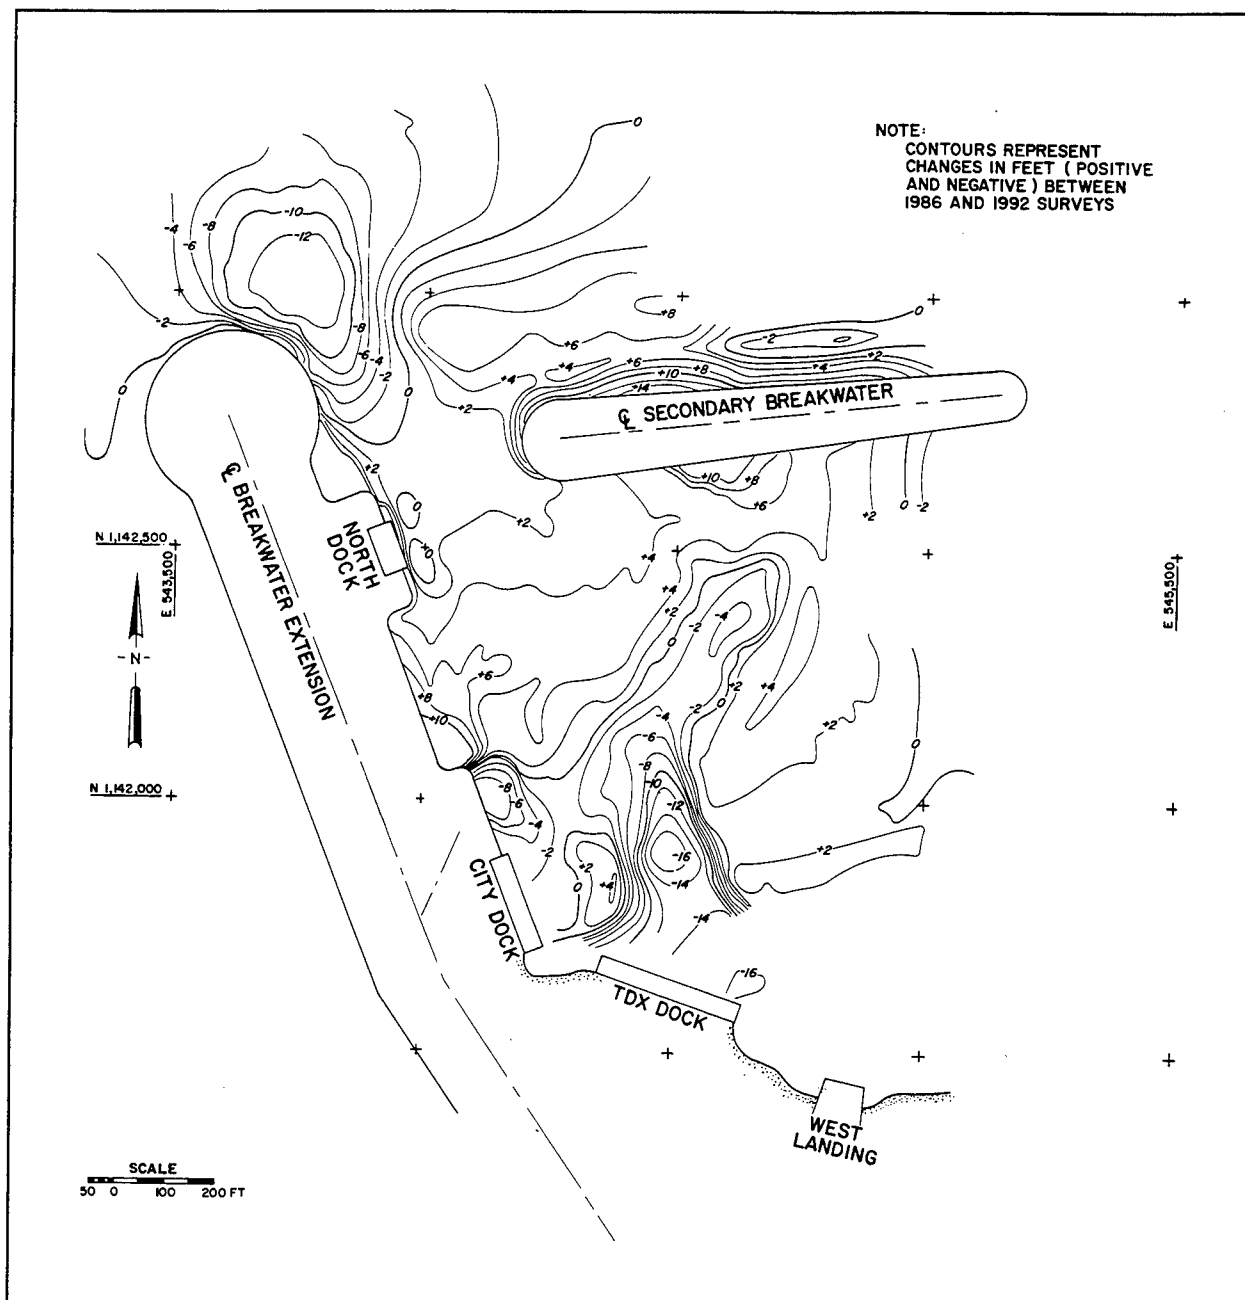
Contours of bathymetric changes that occurred between the September 1986 and the August 1992 surveys are shown in Figure 26. These contours show fill and scour conditions in and adjacent to the harbor. The figure shows a 3.7-m (12-ft) scour hole had formed adjacent to the head of the outer breakwater. In addition, accretion up to 4.3 m (14 ft) had occurred adjacent to the north side of the detached breakwater. An underwater spit had formed north of the west end of the detached structure and has the potential to migrate across the channel. Accretion of 3 m (10 ft) occurred adjacent to the south side of the detached breakwater which suggested sediment may be moving through the structure. Inside the harbor, the scour north of the TDX dock was due to dredging by local interests. Also, the scour hole formed by the original 229-m-long (750-ft-long) outer breakwater appeared to be filling. This may be due to settlement of suspended sediment caused by vessel prop wash, dredging operations, and/or hydrodynamic conditions. The August 1992 survey did not include bathymetry in the area in the lee of the east end of the detached breakwater and adjacent to the shoreline inside the harbor.

Figure 26. Contours of bathymetric changes between September 1986 and August 1992 surveys

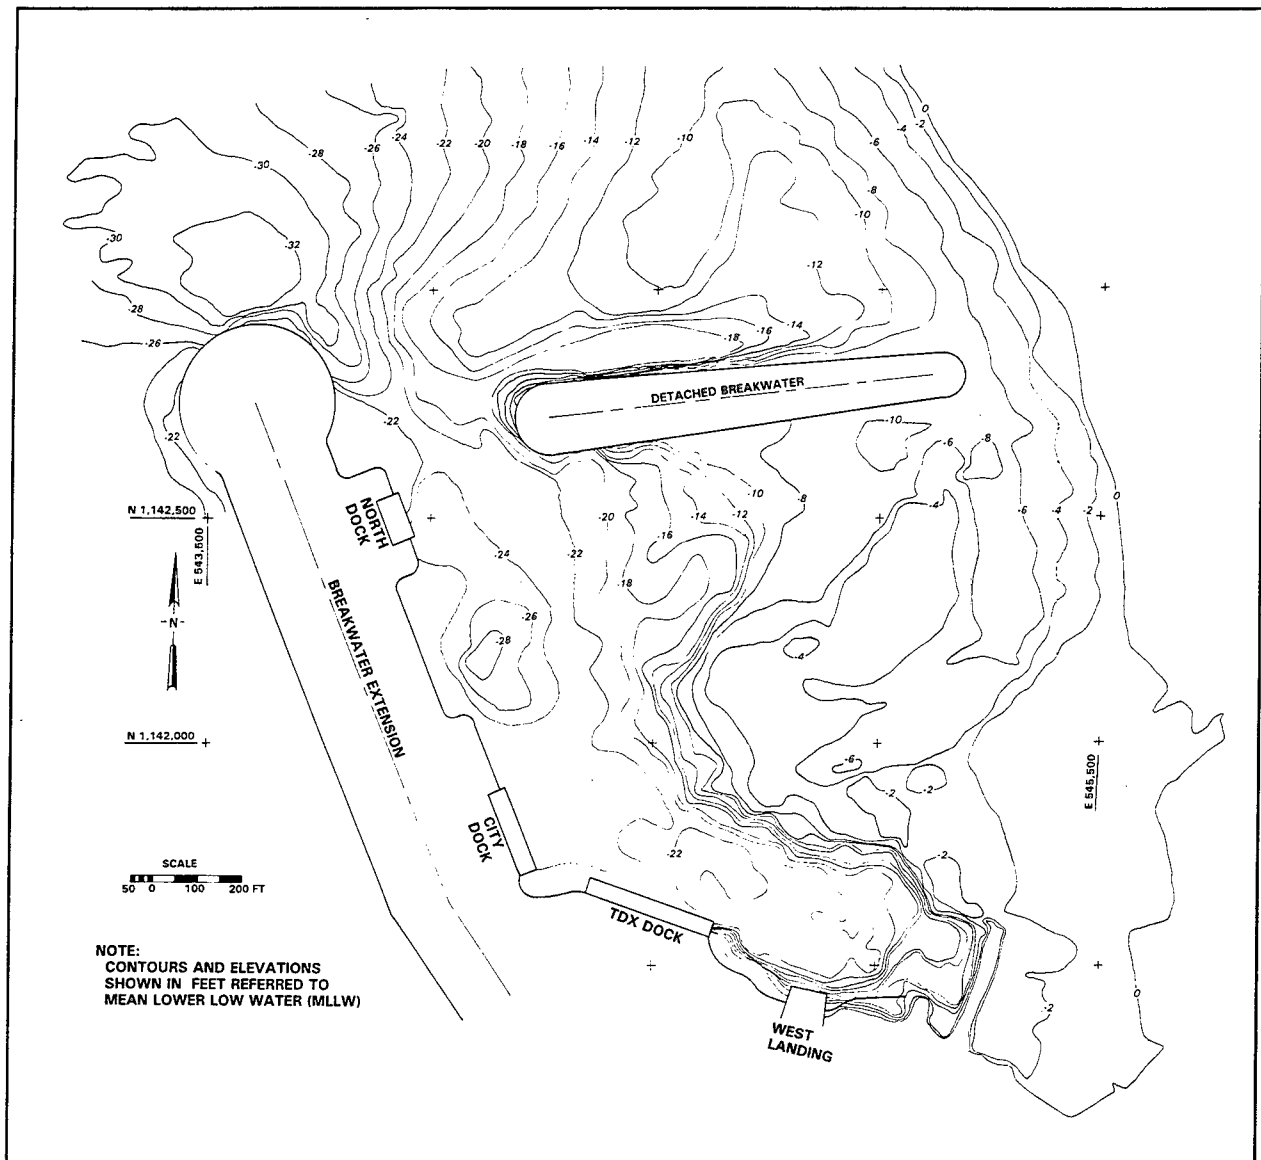
Bathymetric data obtained during the July 1995 survey are shown in Figure 27. The scour hole that had formed at the head of the structure in the August 1992 survey appears to have slightly filled in and shifted slightly west around the head of the structure. To this point, the scour hole has not impacted the stability of the head of the breakwater. The contours north of and adjacent to the detached breakwater are similar to the 1992 survey. To this point, the underwater spit has not had any negative impact on navigation. Local interests dredged an area inside the harbor

Figure 27. Bathymetry at St. Paul Harbor, July 1995

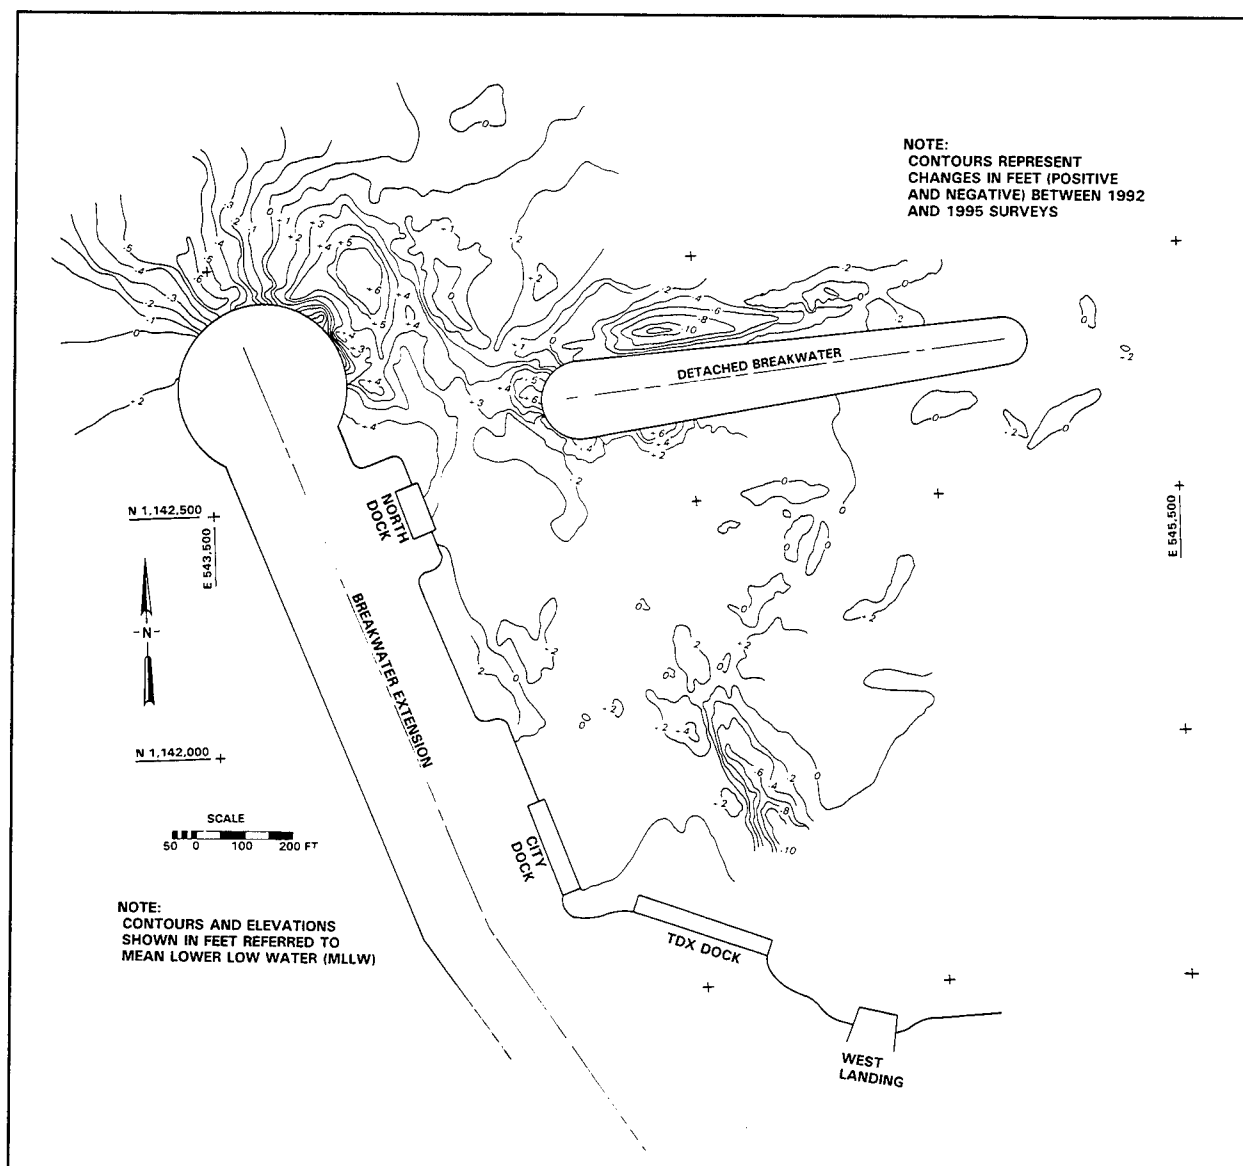
Contours of bathymetric changes that occurred between the August 1992 and July 1995 surveys are shown in Figure 28. The figure shows that the old (1992) scour hole location has filled in about 1.8 m (6 ft), with a 1.8-m (6-ft) cut at the new location to the west. The accretion immediately adjacent to the north side of the detached breakwater in 1992 had subsided by 3 m (10 ft). Not shown on the figure (due to lack of data in 1992), however, is a slight shift in the underwater spit north

of its old location with accretion observed. Accretion of 1.8 m (6 ft) had occurred at the seaward head of the detached breakwater. Cut and fill inside the harbor north of the TDX dock was probably related to the dredging operations at West Landing by local interests.

Figure 28. Contours of bathymetric changes between August 1992 and July 1995 surveys

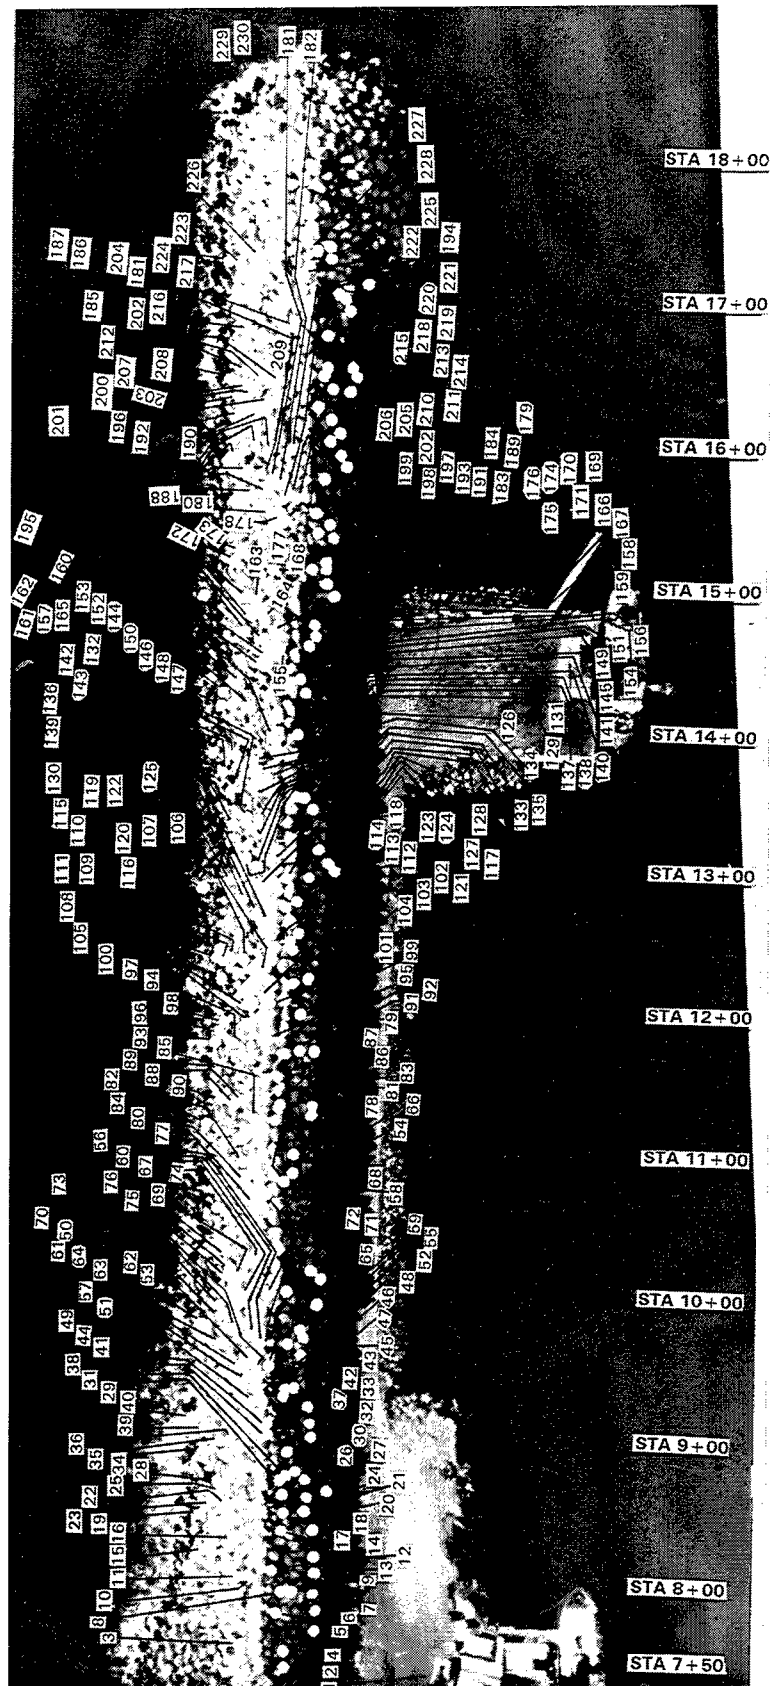
Figure 39. Approximate locations of broken/cracked armor stone on outer breakwater during June 1996 survey

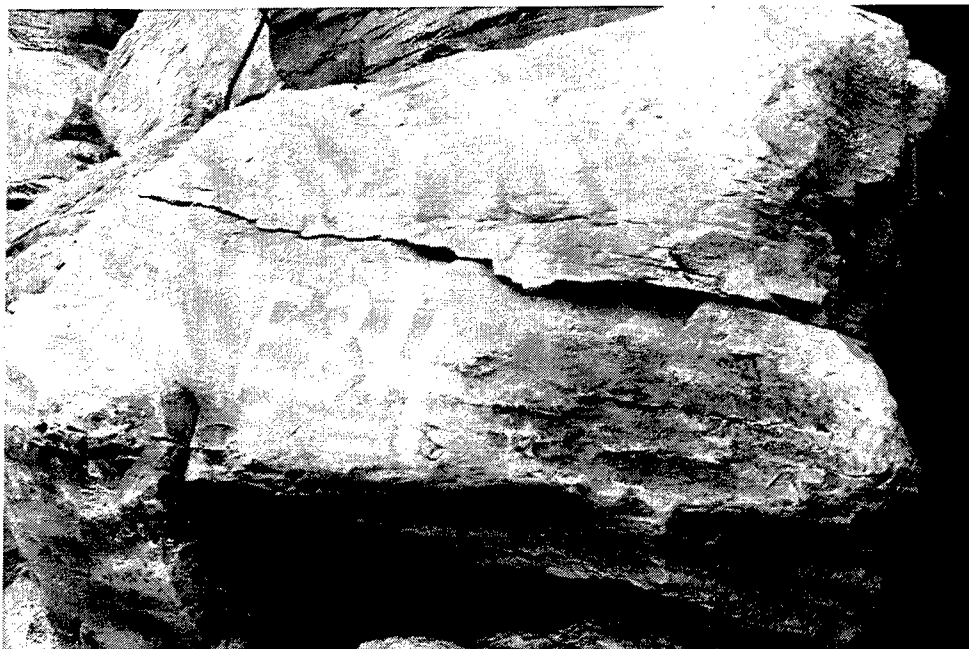
Figure 40. View of broken armor stone on St. Paul Harbor breakwater (station 10+21)

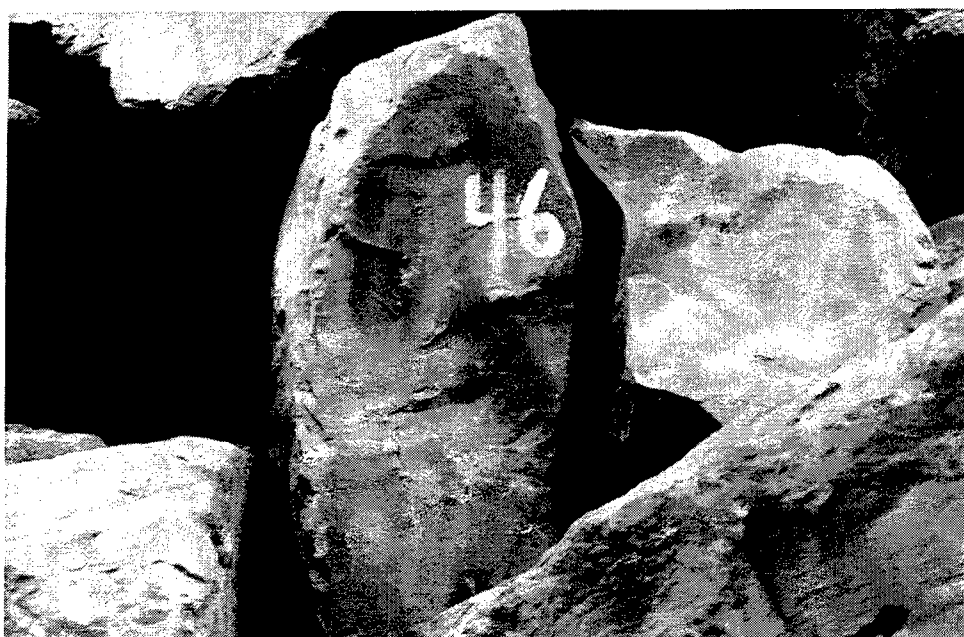
Figure 41. View of broken armor stone on St. Paul Harbor breakwater (station 11+78)

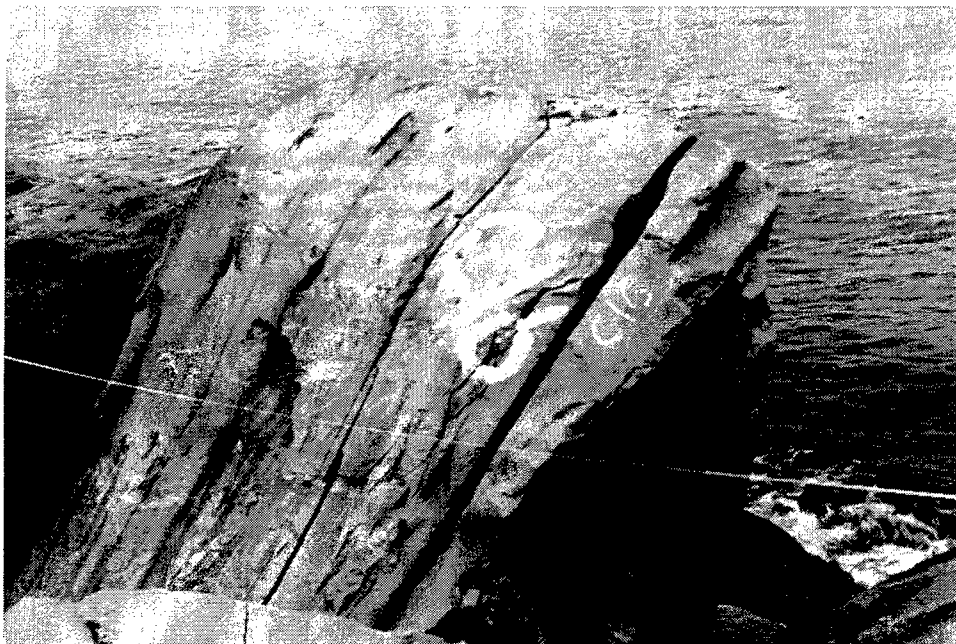
Figure 42. View of broken armor stone on St. Paul Harbor breakwater  
(station 11+87)

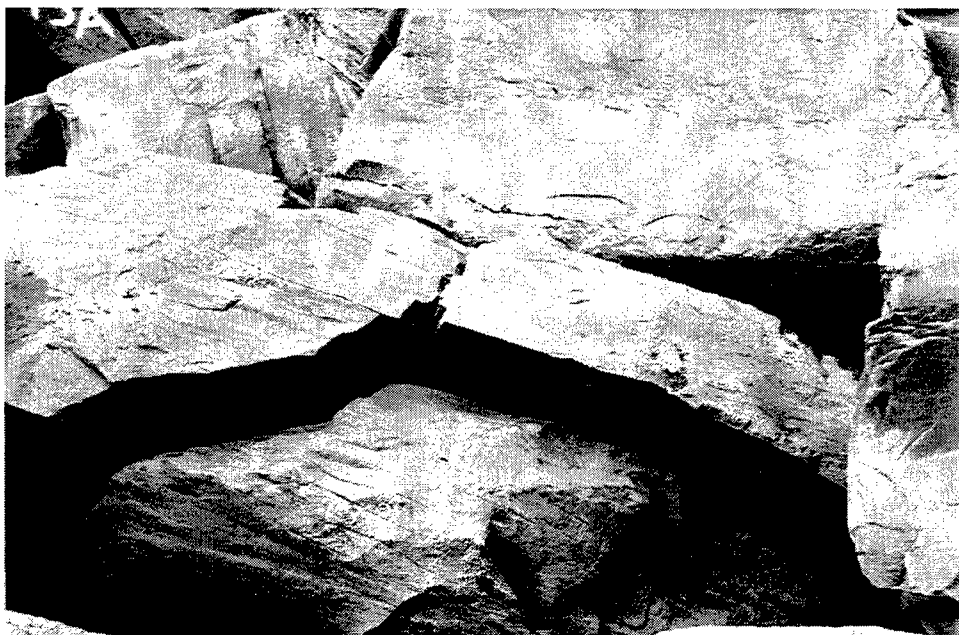
Figure 43. View of broken armor stone on St. Paul Harbor breakwater  
(station 17+34)
